**ROOFING - AN INVESTIGATION, AND RECOMMENDATIONS  
FOR IMPROVING PERFORMANCE ON  
ALBERTA GOVERNMENT BUILDINGS**

Department of Public Works  
Government of the Province of Alberta  
August, 1967.

RE: Roofing

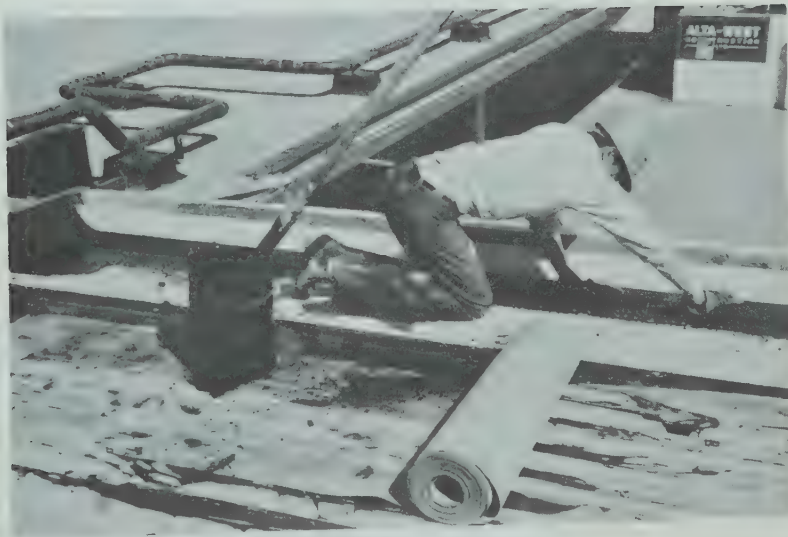
78. Pressing edge cutoff strip in place.

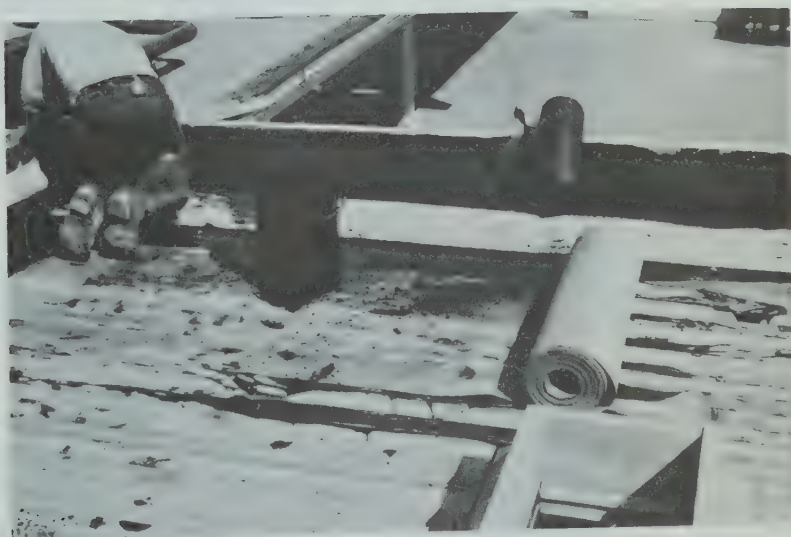
80. Pressing in place of starter strip - (one slip of the boat and a hole is made in the base sheet!). The workmanship on this job was far above average.

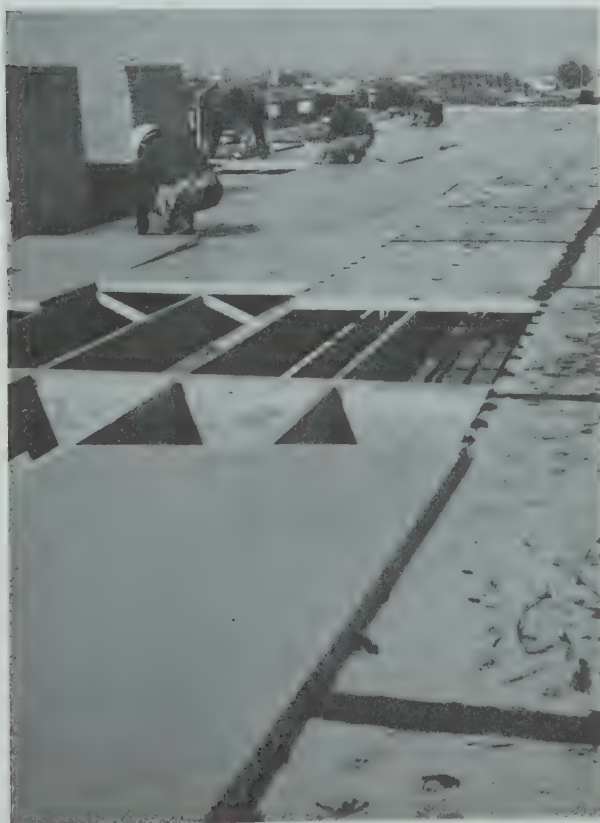
82. Stramit being nailed to joists at 2 ft. o.c.  $3\frac{1}{2}$ " coated nails at 10" o.c. placed along edges.

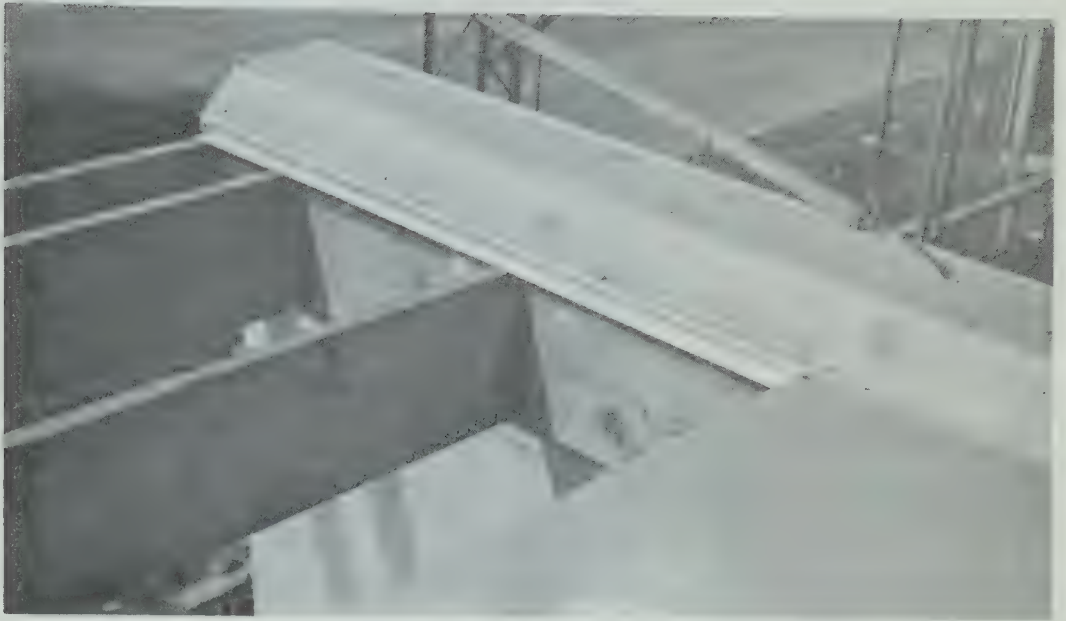
85. End "ell" for support of end of Stramit. Note that cant strip is nailed to joists, and not placed over Stramit.

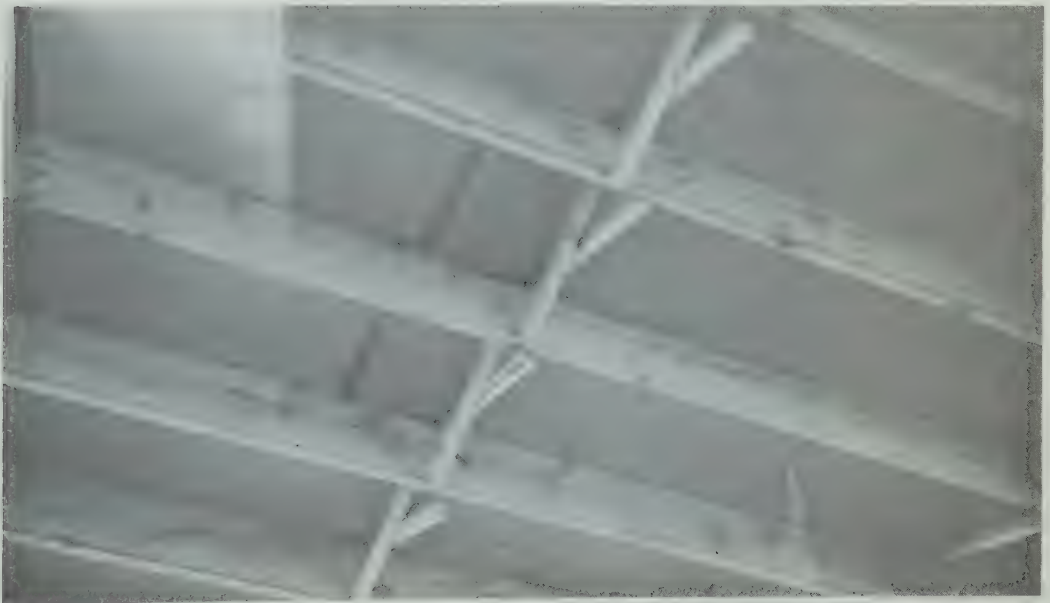
86. Underside of Stramit deck - this installation used exposed paper type board on soffit - a few cents cheaper, but unwise if humidity on interior is above normal.

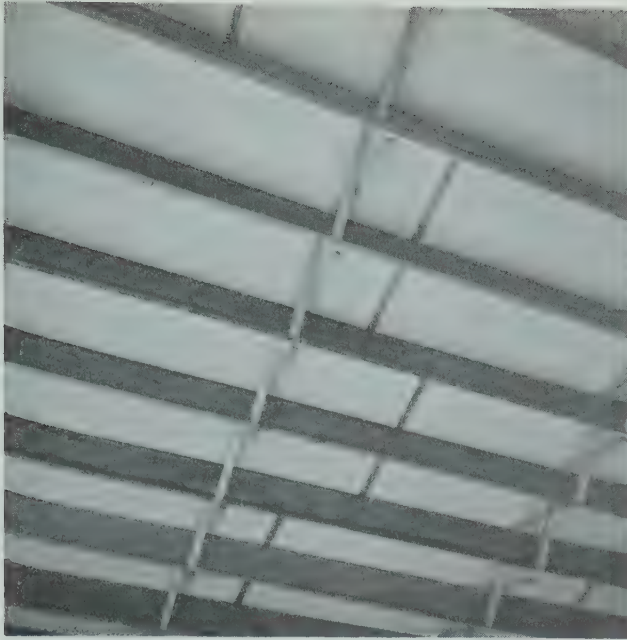
87. Underside of Stramit deck - vinyl covered sheets used in this installation.

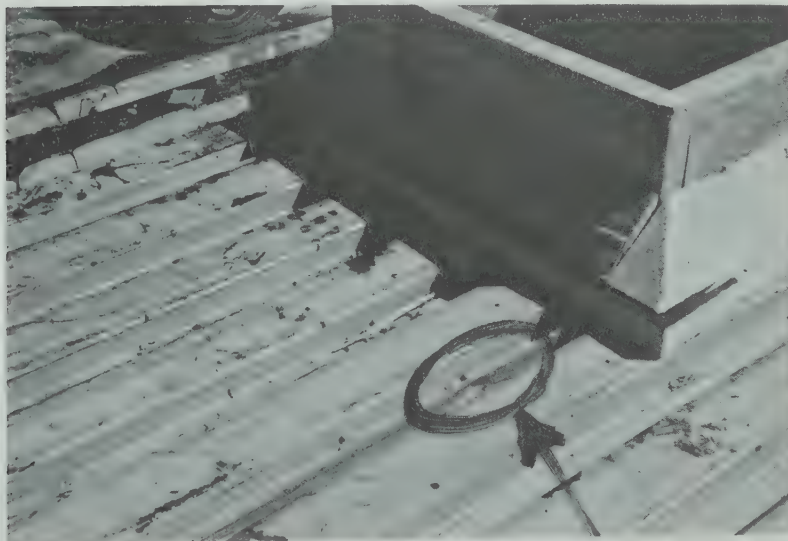
90. Button punching at close centers (max. 2' - 6") is essential to prevent differential deflection of metal deck sections.

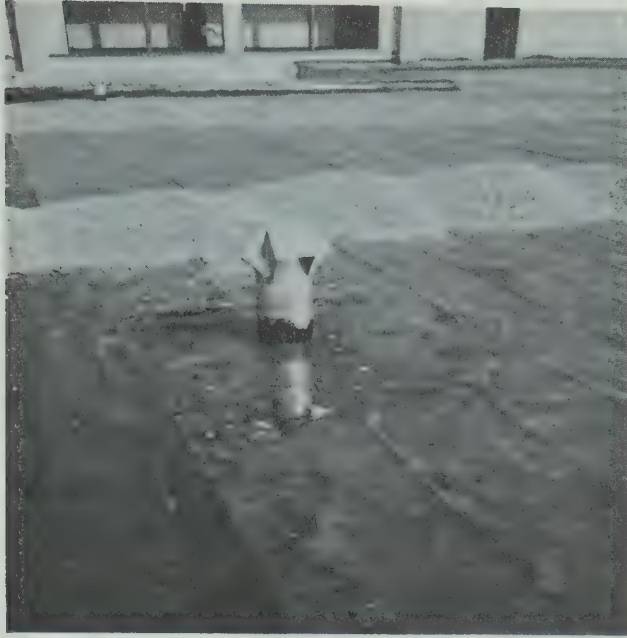
92. Roof vent (one per 1000 sq. ft. of deck) as recommended for installation over Zonolite insulating concrete deck. The picture also shows that gravel was prematurely stored on the roof.

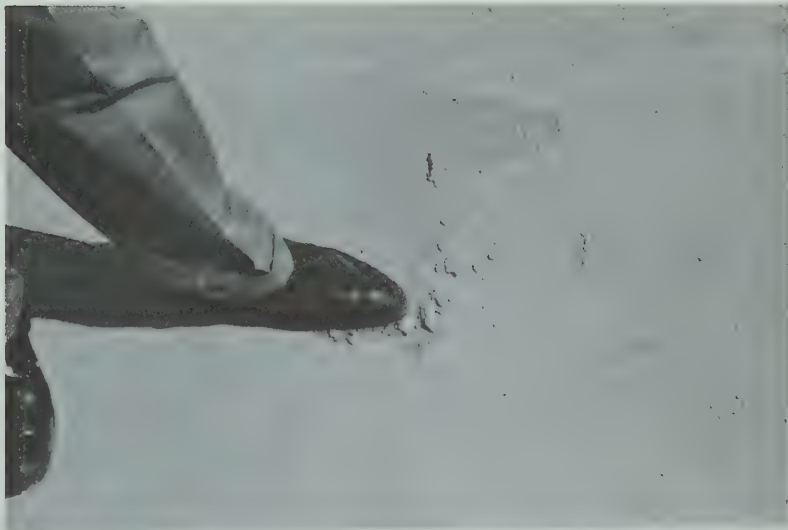
93. Surface of Zonolite topping prior to priming. This material is an insulating lightweight "concrete".

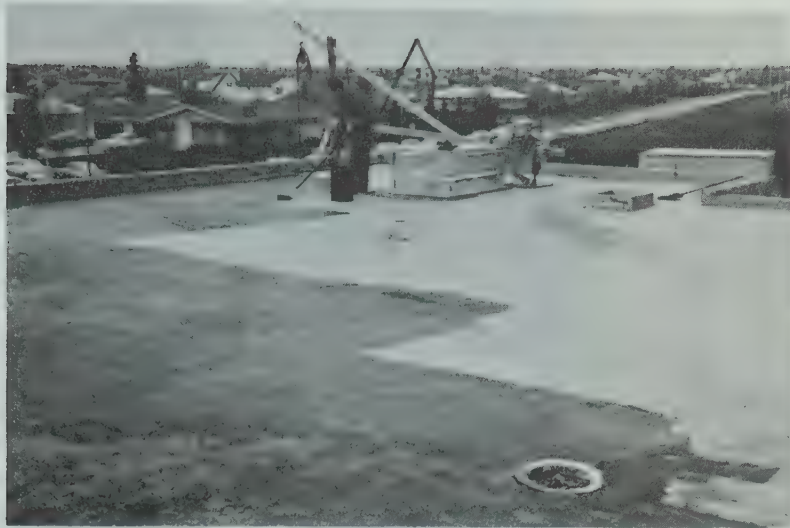
96. Priming of Zonolite deck with cold asphaltic primer.

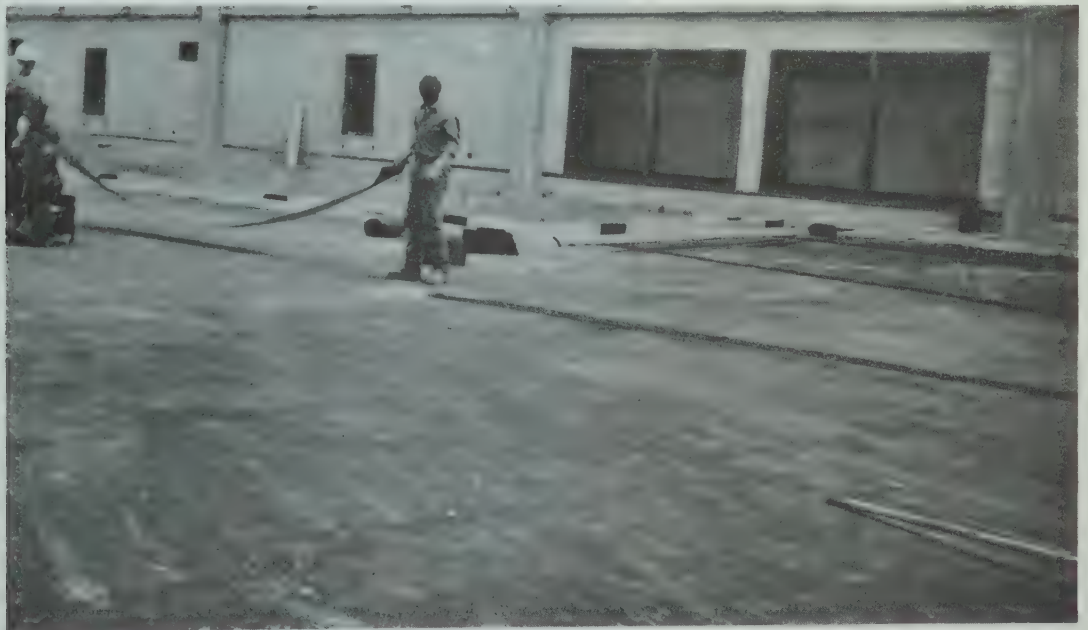
97. Laying of rag felt "wicks" in sprinkle mopping.

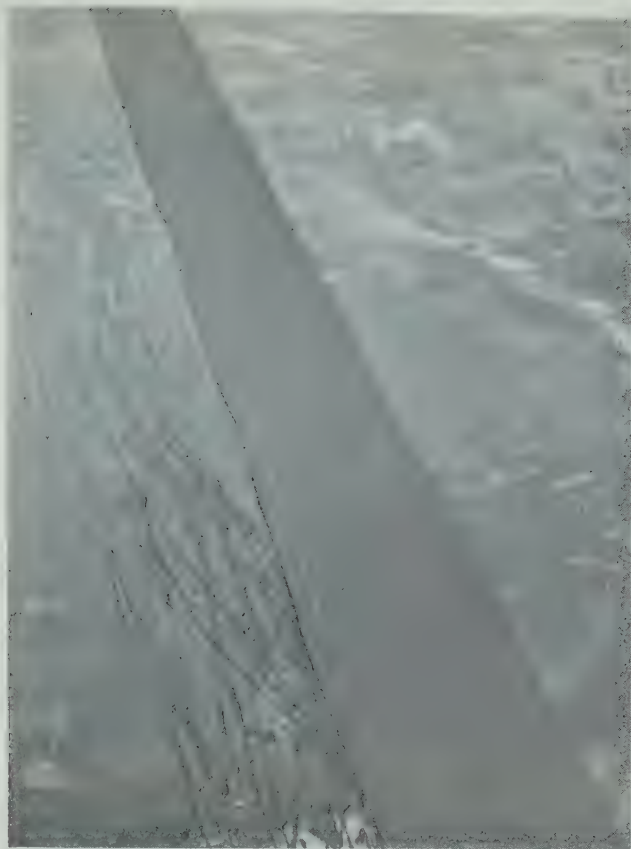
98. Sprinkle mopping - continuous vapour paths intended are not in evidence.

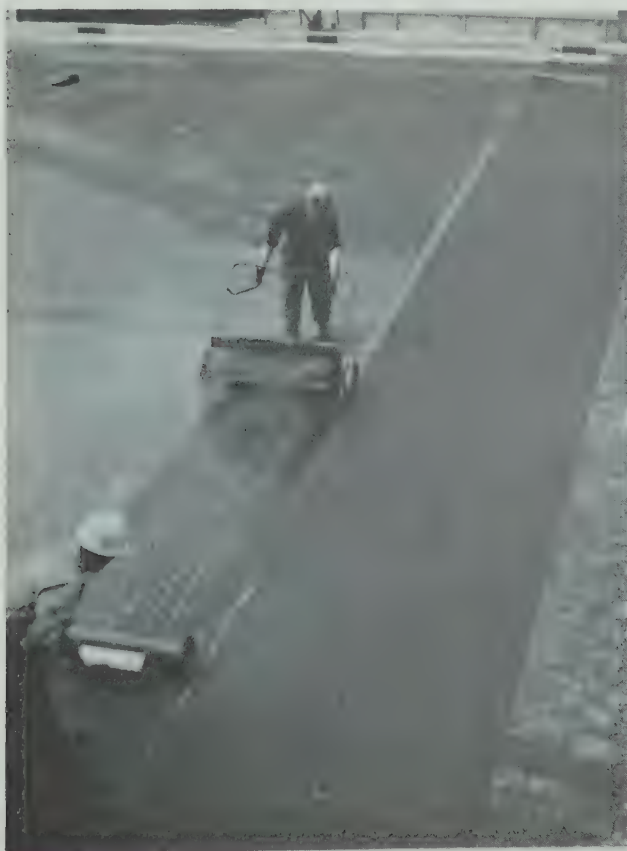
99. Channel mopping - it is doubtful if this application performs as intended. Single ply 15# rag flet is being applied over primed and "wicked" deck.

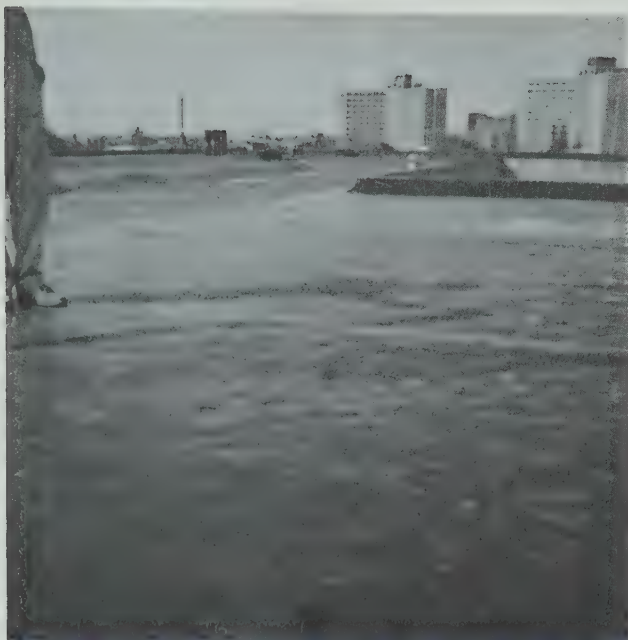
100. The day after roof was completed - note large blisters in membrane.

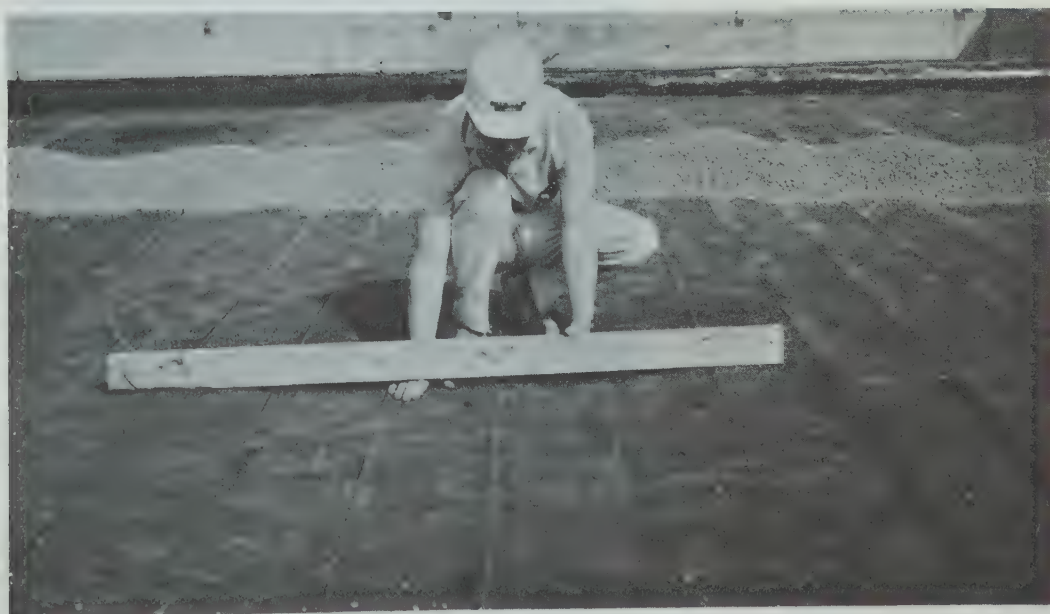
101. Blister in membrane.

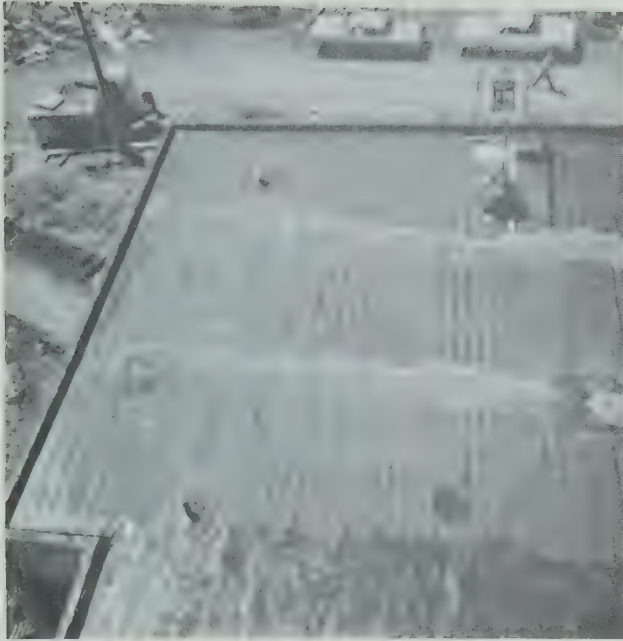
102. Completed roof. Gravel should not be stockpiled on roof. Note only a small portion of membrane has been glazed to protect from moisture and sun-curling.

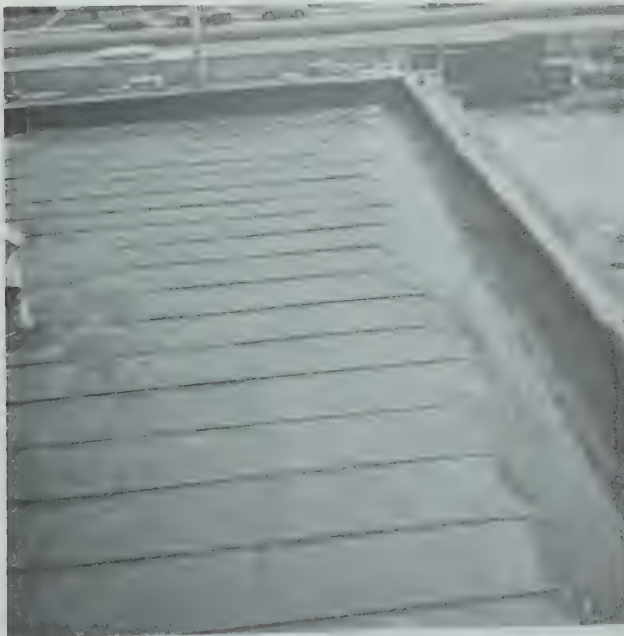
103. Sun-curling of unprotected felts left exposed for several days. This condition may or may not result in future problems, but general opinion is that this condition should not be allowed to develop.

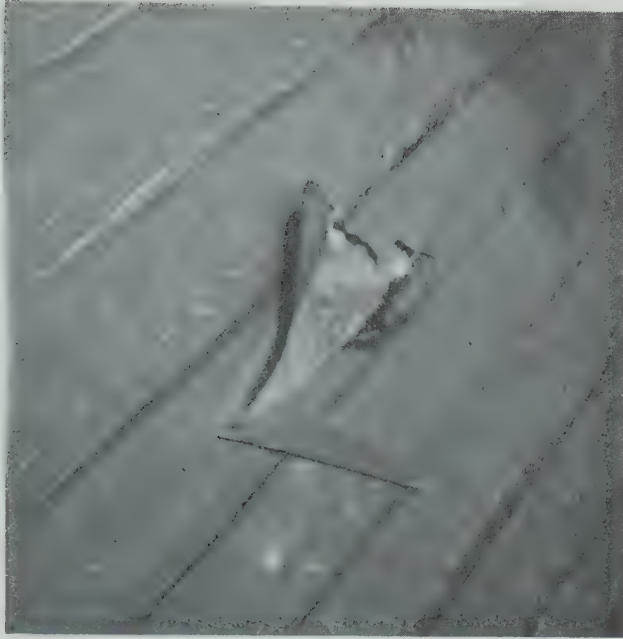
104. Pierced blister - note absense of asphalt bond to substrate.

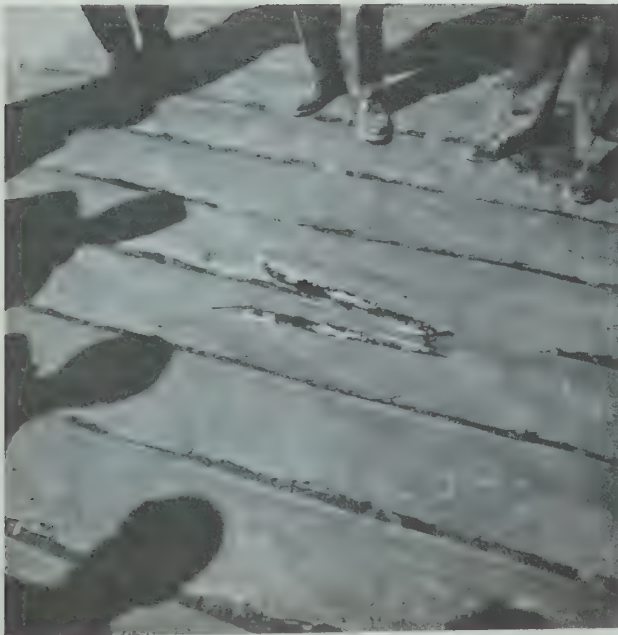
105. Pierced blister of membrane layed over Zonolite deck. Note the top surface of the Zonolite adhering to the asphalt. What is holding this membrane down in hot weather, other than the weight of the membrane, pour coat and gravel? (approx. 7 psf).

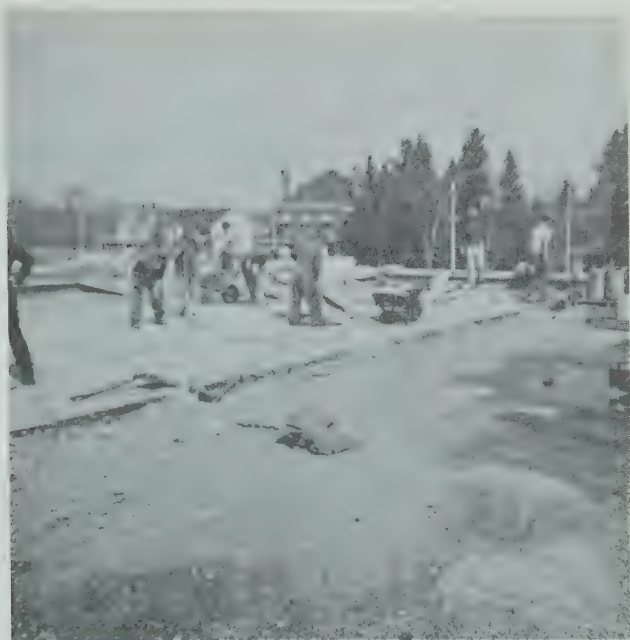
106. Removal of wet wood fibreboard insulation from Museum and Archives Building, low North roof.

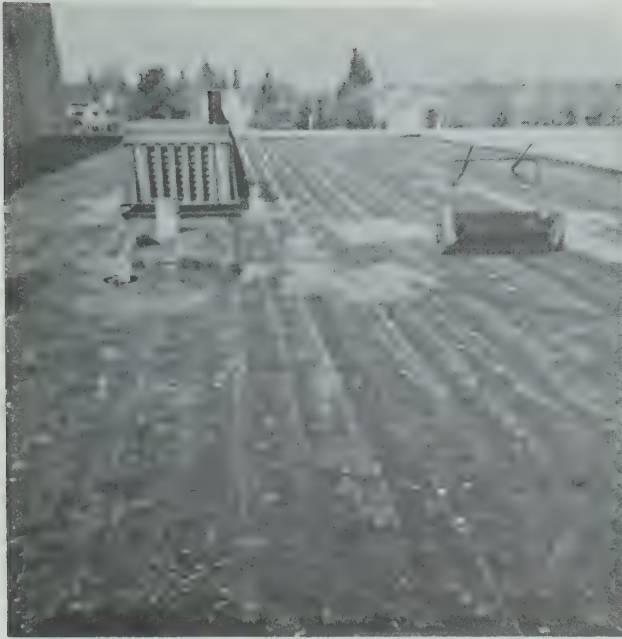
108. Re-laying of 3 ply glass felt membrane over replaced insulation.

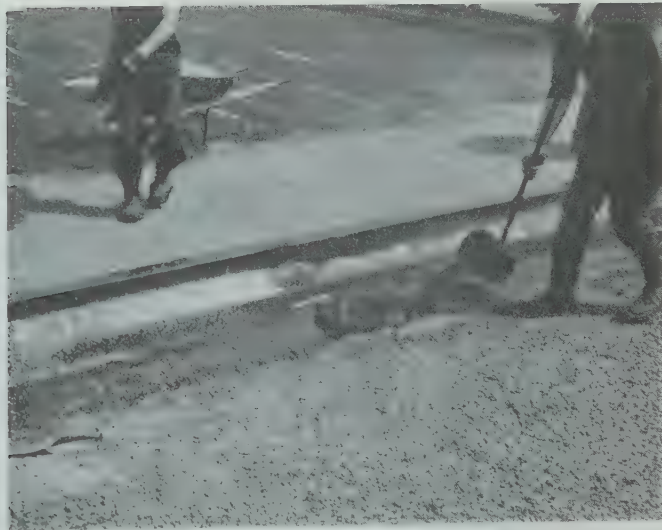
109. Reseating of flashings - without complete removal of flashings, and reinstallation after completion of reroofing, this is the only way the bent up flashings can be held down. Note wheelbarrow full of gravel parked on unprotected membrane.

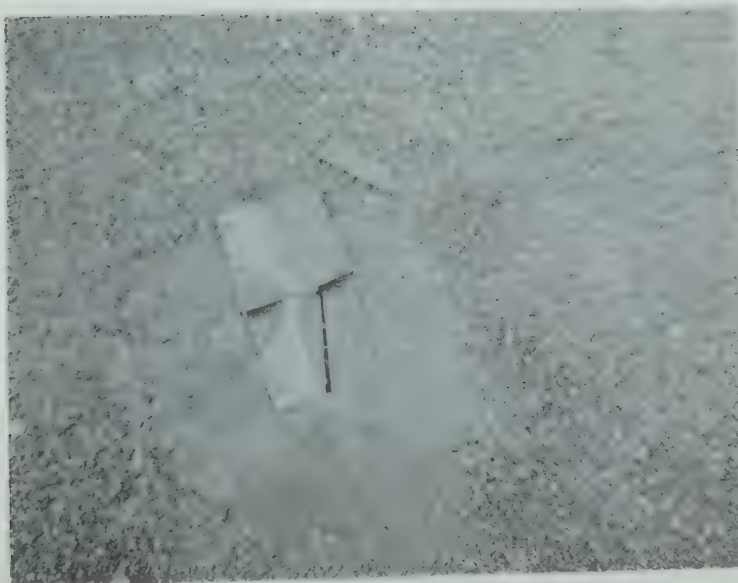
114. March 20, 1967 - "B" Block - Patch cut out of membrane reveals uncaulked joint in Stramit insulation. Gap is  $3/8$ " wide.

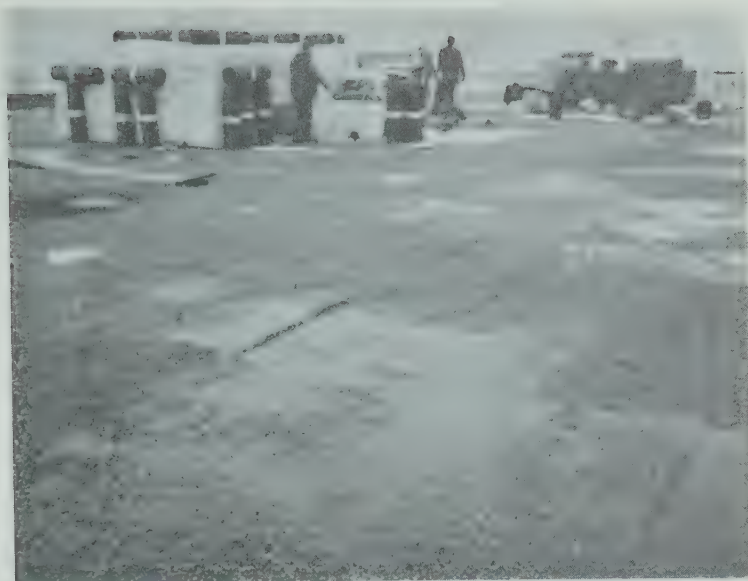
115. Below freezing weather, but water standing on the roof.  
Note ridging of membrane at end joints of insulation.

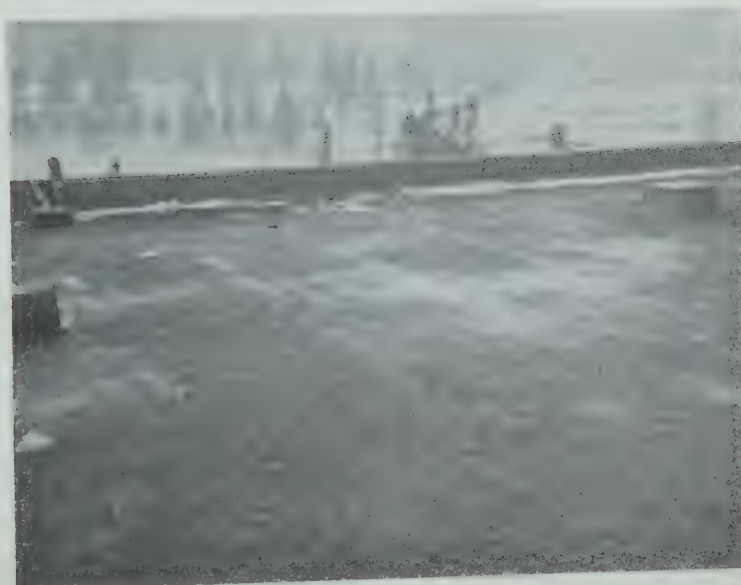
116. Note sagging of membrane at edge joints of insulation, as  
shown by water pattern.

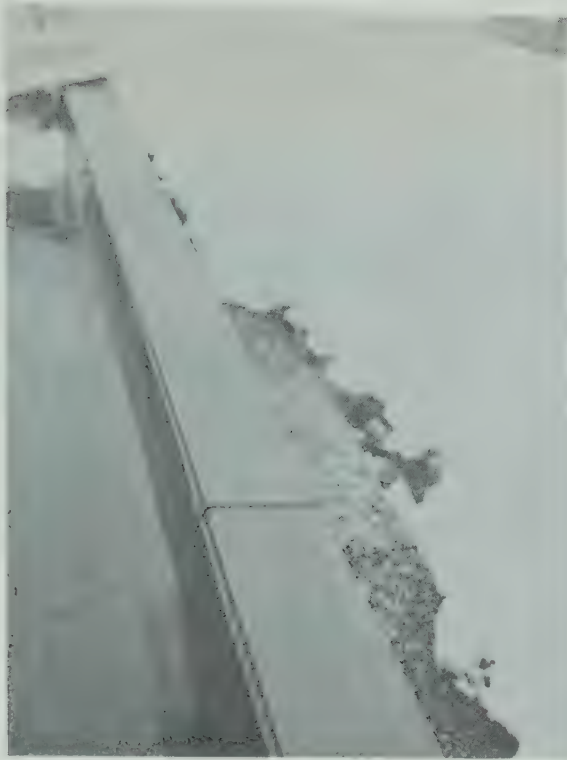
119. Snow melted through action of warm air escaping from building interior.

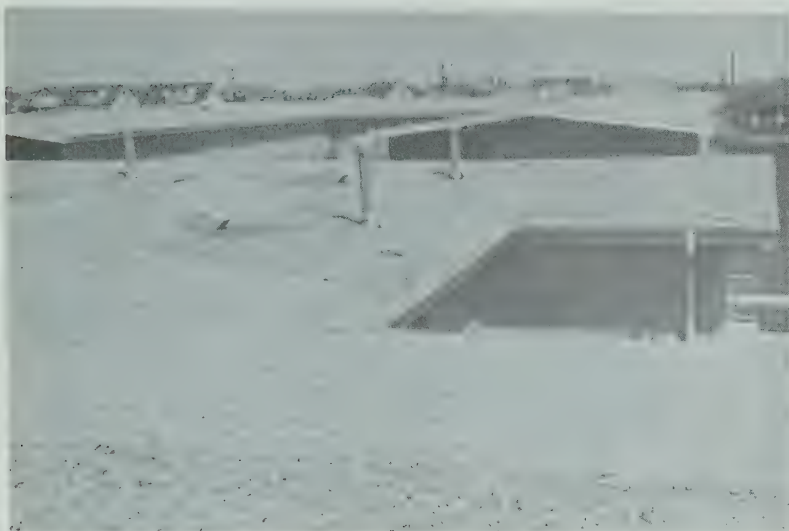
123. Low pitched roofs of "H" unit and Lodge. Roof construction is Structural Stramit over wood joists. Membrane is 3 ply of 8# glass felt.

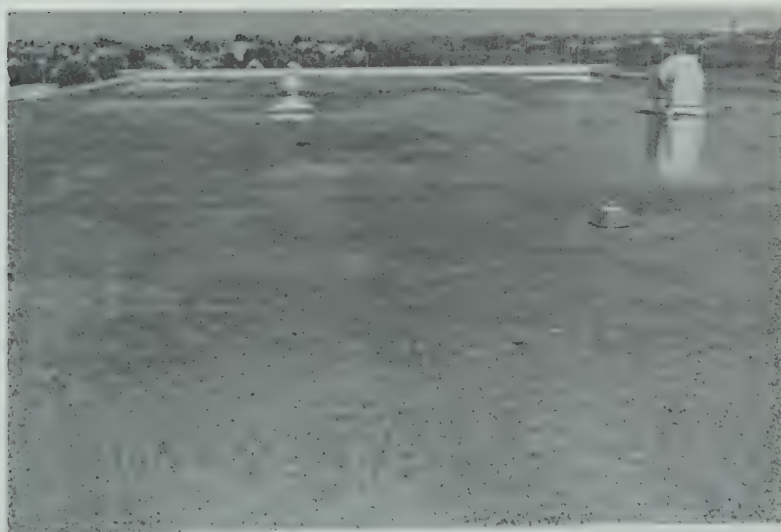
129. Reroofed area - dry roof drain and ponds of water laying up against flashings.

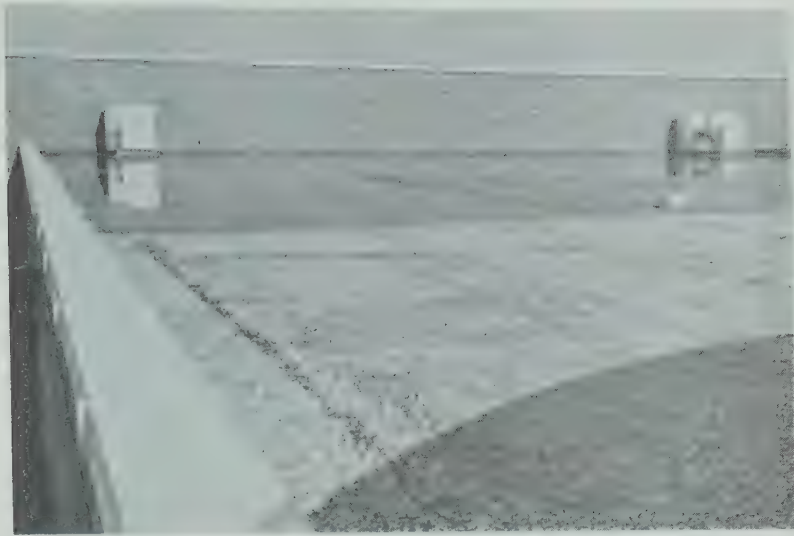
130. Reroofed area - serious water ponding against gymnasium wall flashing. This area was done by a roofing contractor. Note the dip of surface, as defined by line of water.

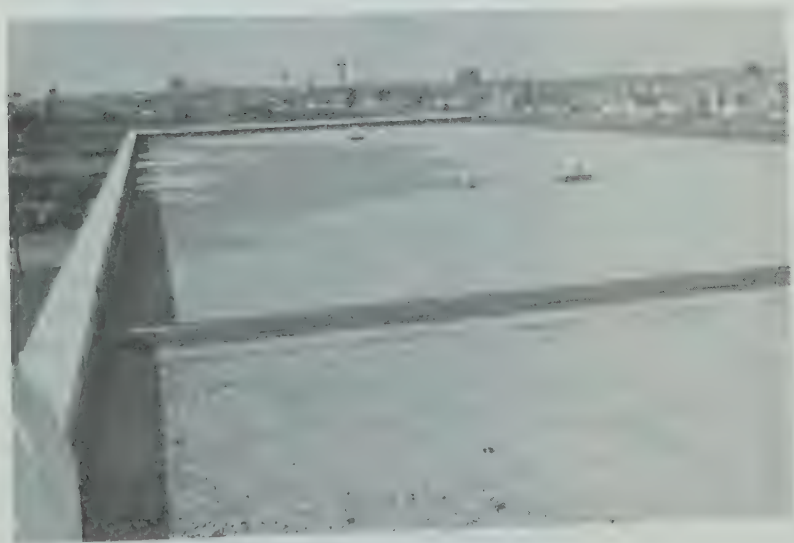
131. Reroofed area (fall 1966) done by D.P.W. crews. Neat job well done. Foreground shows contractor reroofing job. This area was flashed using standing seams.

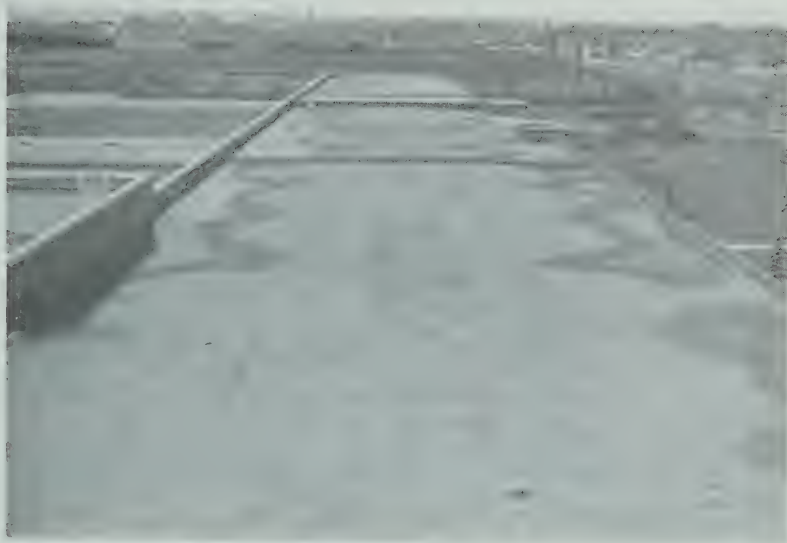
132. Looking north - all areas shown have been reroofed with Stramit and rag felts. Note insulation joint pattern visible. Pour coat and gravelling skimpy here. All areas south of the main entrance, and all wings have been reroofed with wood fibreboard and rag felts. All reroofed areas now incorporate a vapour barrier.

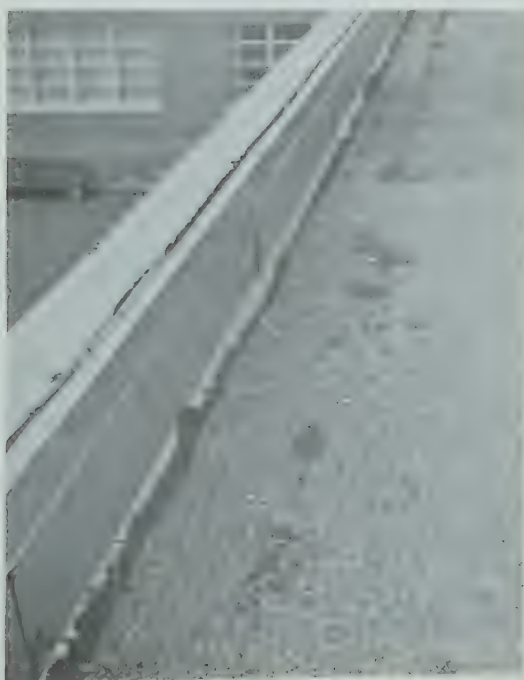
133. Top of cap flashing slopes properly to shed water, and drops  $4\frac{1}{2}$ " over base flashing. Seams are "S" bend. Note, however, that base flashing has been anchored to the membrane. This procedure is not generally considered good. The parapet and flashing should be free to move independently of the membrane.

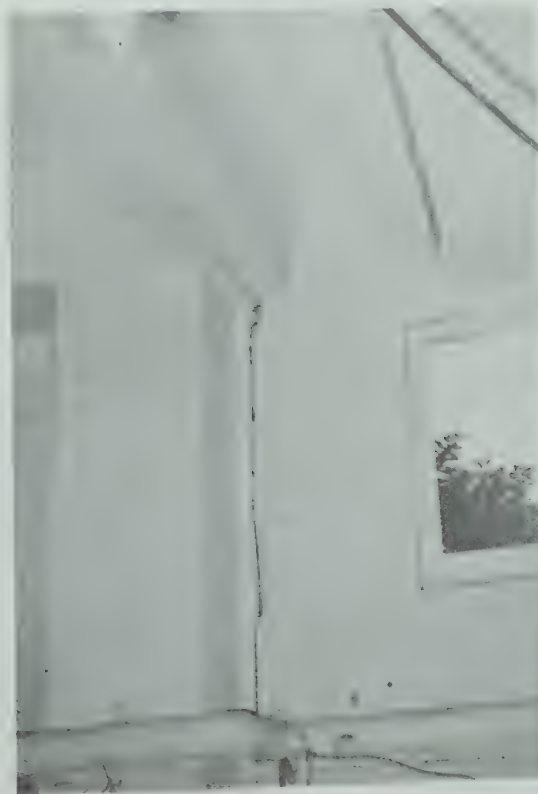
137. Control joint in basement wall and main floor slab.

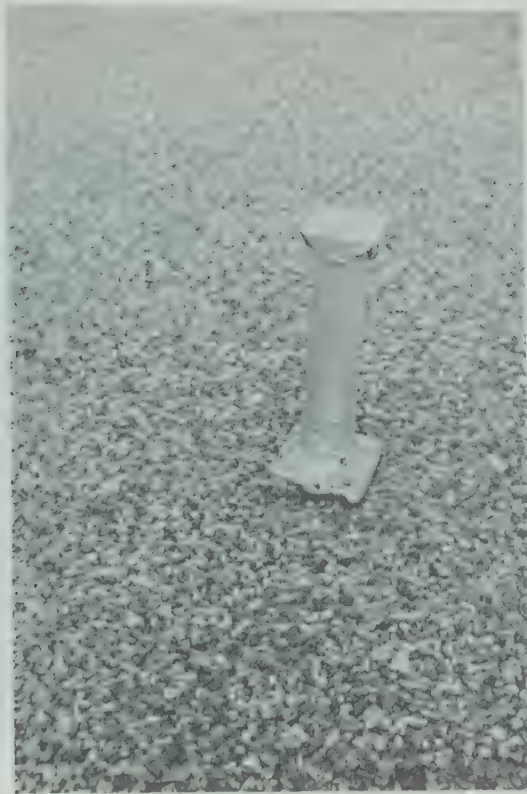
138. Vapour pressure relief vent installed as precaution. The original roof design of the School for the Deaf called for a vapour barrier, however, this was deleted by D.P.W. request. The open type T- bar and egg-crate ceilings, along with the precast double Tee deck offered no resistance to the penetration of moisture into the insulation.

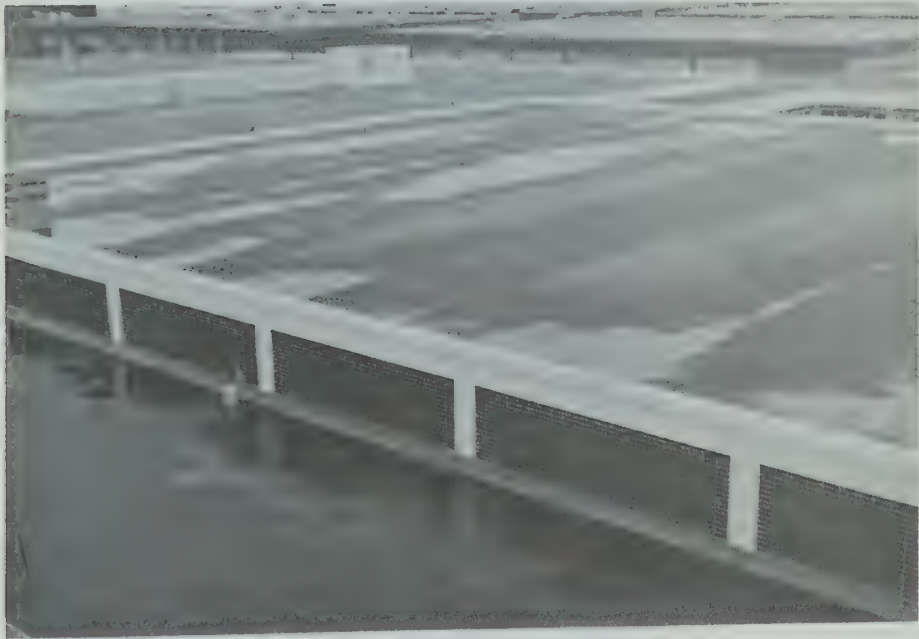
140. Phase II Library & Auditorium roof - note water standing remote from drain. The flashing seen is all new.

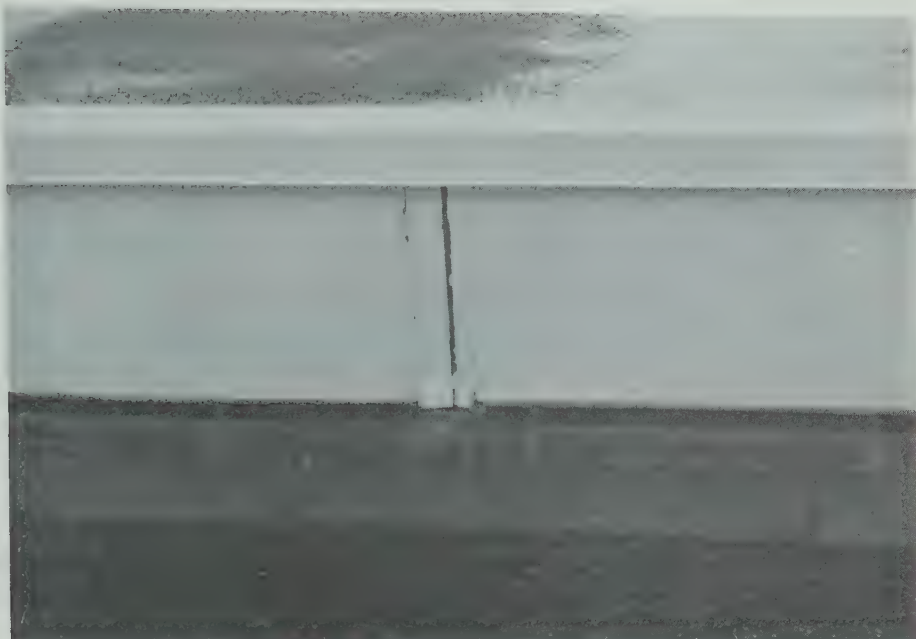
141. Illustration of continuing building movement - paint has flaked from the metal. Original detail had joint caulked, with small strip of flashing over top of beam at joint. Metal strip has been applied over joint, entire top has been flashed, and counter flashing has been reset into reglet.

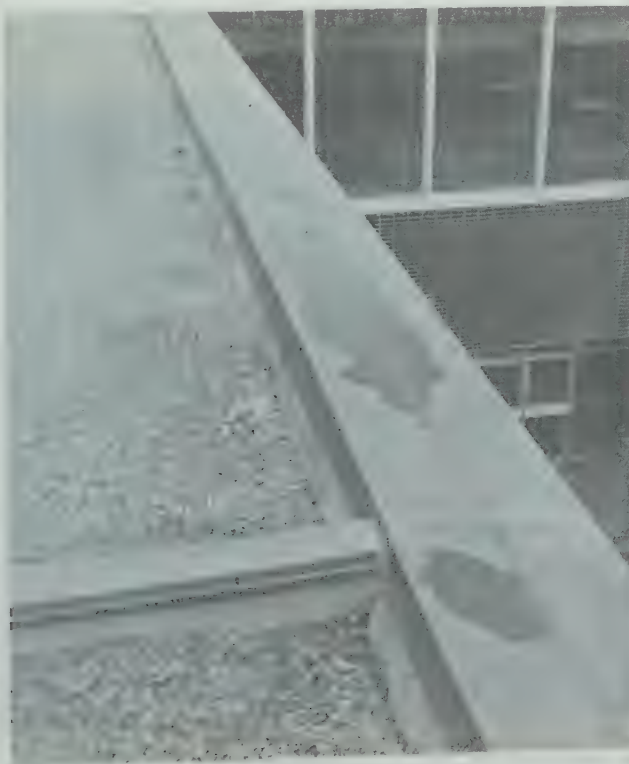
142. Phase III original copper flashings - note water retained.

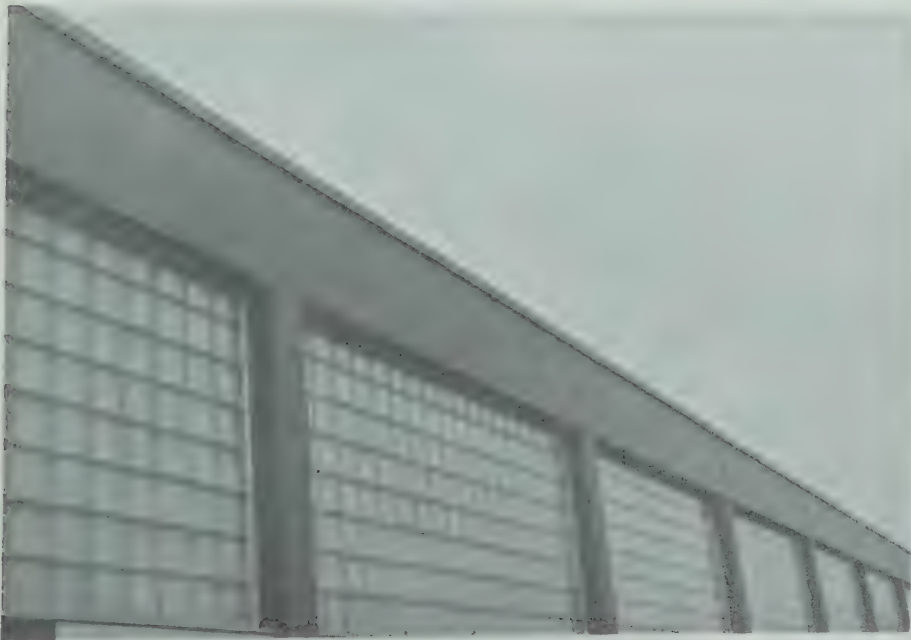
150. Reflashing - typical for entire building. Original detail was as shown in fig. #19.

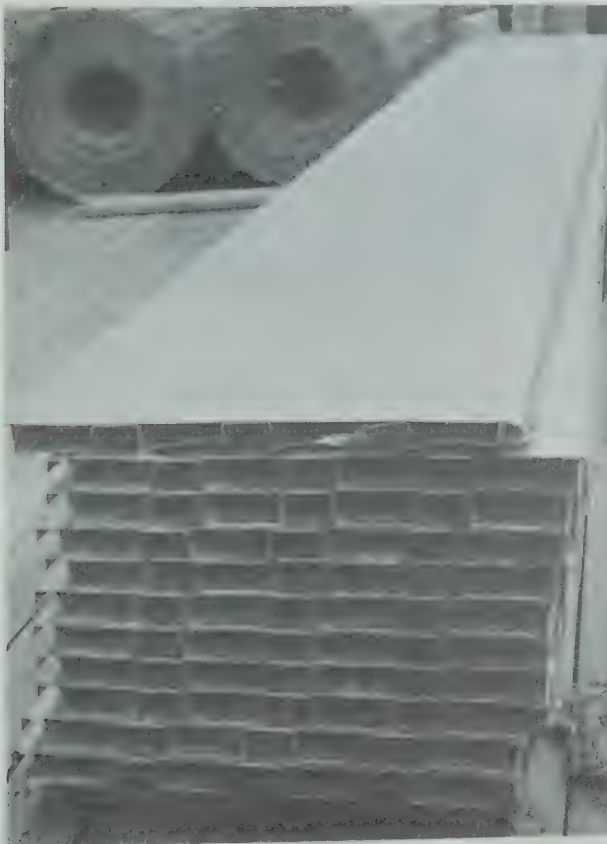
154. Metal deck - this type when installed produces flat roof deck surface rather than fluted.
